Manhole Inspection Summary

Manhole # S23UU1008MH

Location Address: **24 INDIAN LN**

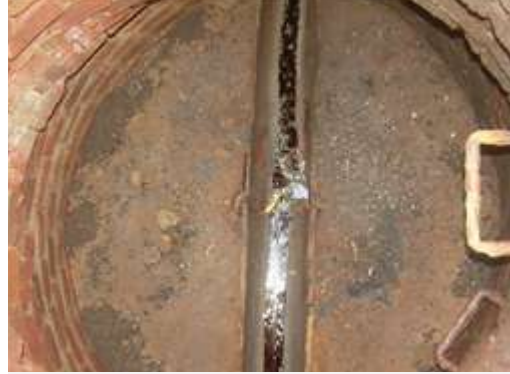
Top View

Corroded steps. Evidence of surcharge - Bench debris.

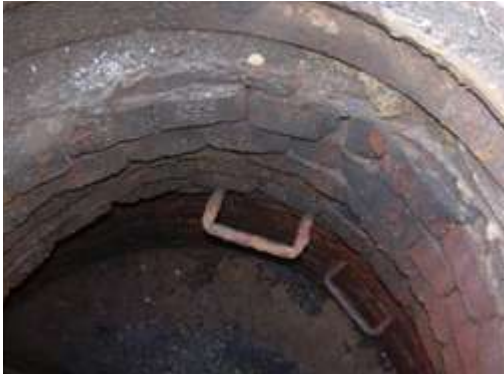
Defect

Frame leaks. Frame offset. Adjustment deterioration and infiltration. Corbel and Barrel infiltration.

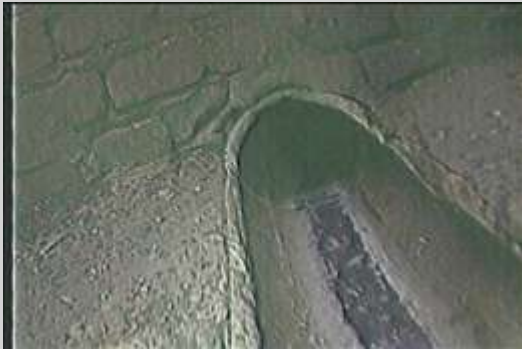
6 in. Circular Gravity Sewer Pipe Out @ 12 O'Clock

Infiltration: **Evidence** Pipe Seal Cond: **Broken**

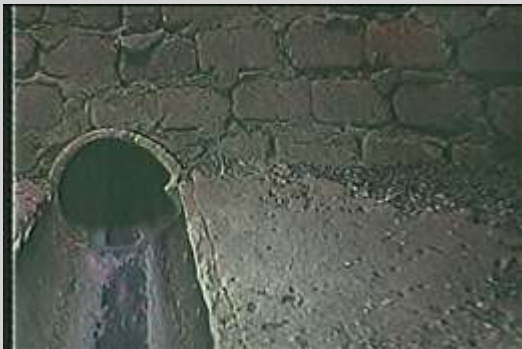
6 in. Circular Gravity Sewer Pipe In @ 6 O'Clock

Barrel deterioration and infiltration.

Infiltration: **Evidence** Pipe Seal Cond: **Broken**
